Storm-induced Habitat Modifications caused by Hurricane Sandy within the U.S. Atlantic Coast Breeding Range of the Piping Plover (*Charadrius melodus*)¹

Tracy Monegan Rice
Terwilliger Consulting, Inc.
December 2015

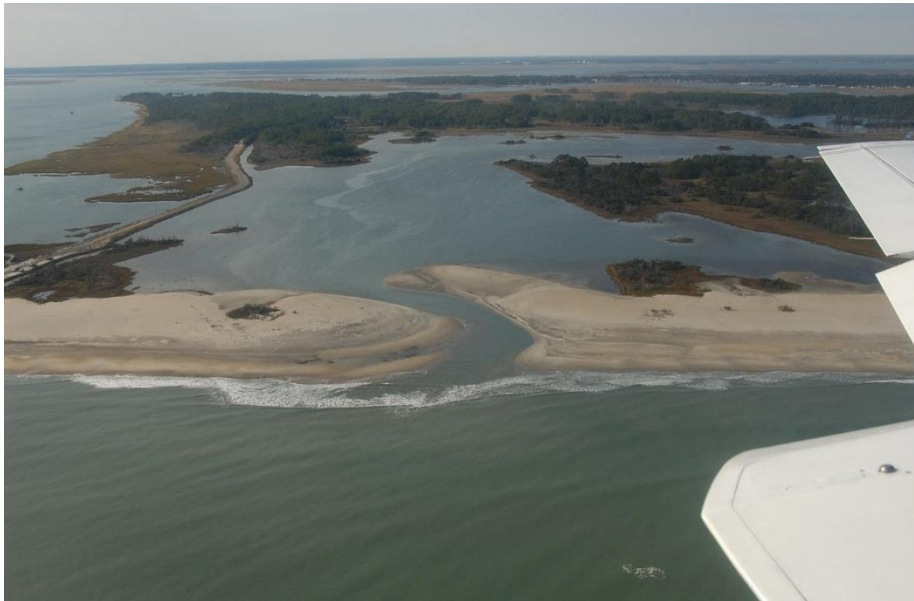
Figure 1. Hurricane Sandy opened an inlet at Chincoteague NWR in Virginia, north of the causeway. Image from USGS (2015) dated November 4, 2012.

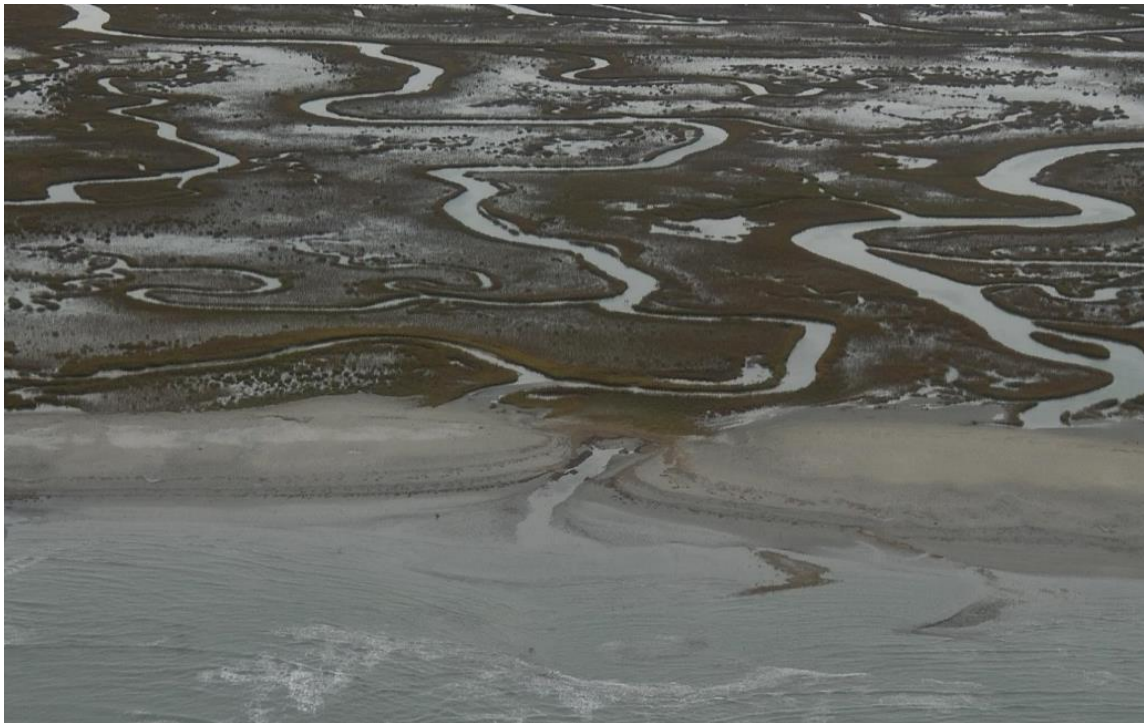
Figure 2. An unnamed inlet on Myrtle Island, Virginia, was closed by Hurricane Sandy. The inlet had opened naturally in 2009 (Rice 2014). The storm overwashed the island and filled the tidal channel connected to the inlet with sediment, visible on the left side of the image. Sediment subsequently filled in the seaward portion of the inlet. Image from USGS (2015) dated November 4, 2012.

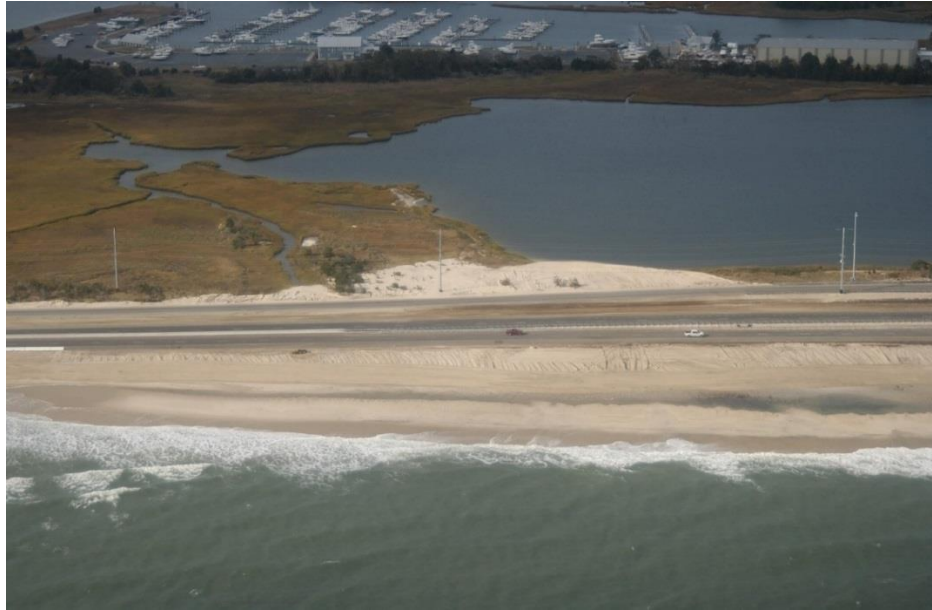
Figure 3. Overwash occurred in limited areas in Delaware, most notably north of Indian River Inlet in Delaware Seashore State Park. Nearly all of the overwash deposits were scraped back onto the beach to form artificial dunes within one week of the storm, as seen in this image from near the Indian River Marina where the overwash extended across both roadways on the barrier spit to the bayside. Image from USGS (2015) dated November 6, 2012.

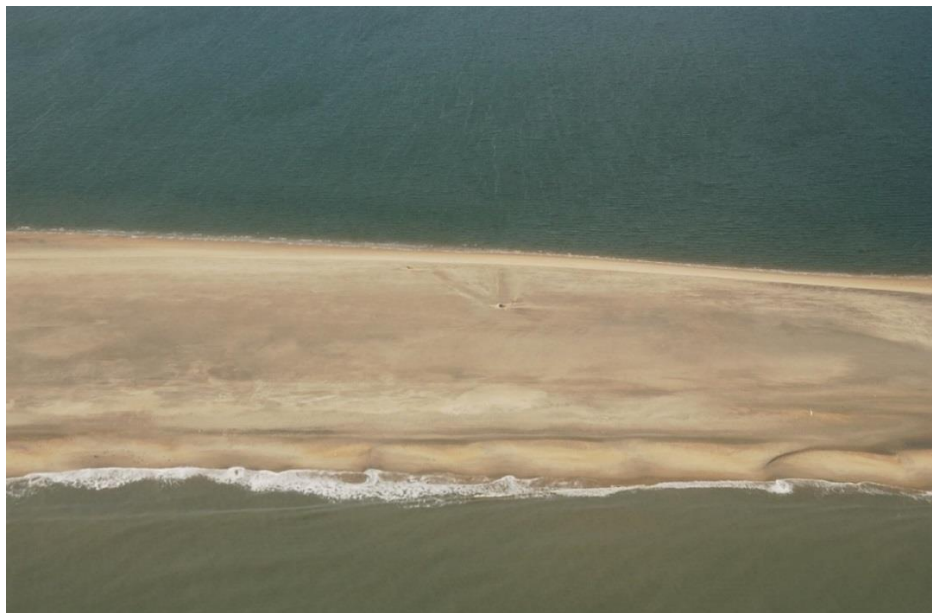
Figure 4. The southern end of Chincoteague NWR in Virginia was overwashed by Hurricane Sandy. The narrow spit connecting Toms Hook to rest of Chincoteague / Assateague Island was overwashed completely, from ocean (the bottom of the photo) to the Toms Cove (the top of the photo), forming sheetwash type overwash deposits. Image from USGS (2015) dated November 4, 2012.

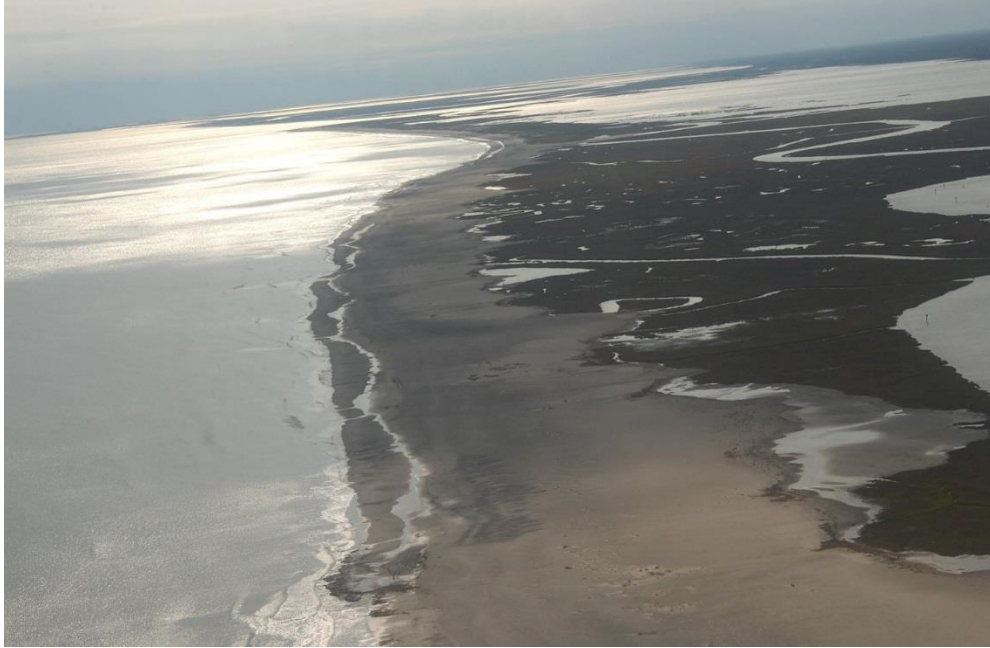
Figure 5. The barrier islands along Virginia's Eastern Shore were extensively overwashed by Hurricane Sandy. On some islands, overwash modified virtually all of the sandy beach habitat such as at Metompkin Island, seen here looking from north to south. Image from USGS (2015) dated November 4, 2012.

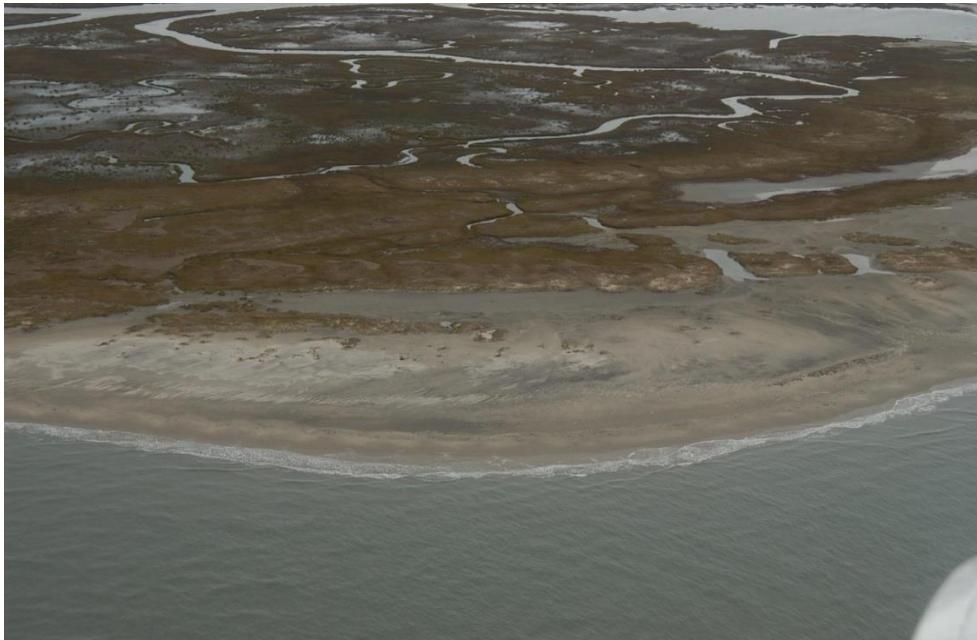
Figure 6. The barrier islands along Virginia's Eastern Shore were extensively overwashed by Hurricane Sandy. On some islands, overwash modified virtually all of the sandy beach habitat such as at the north end of Ship Shoal Island as seen here. Image from USGS (2015) dated November 4, 2012.

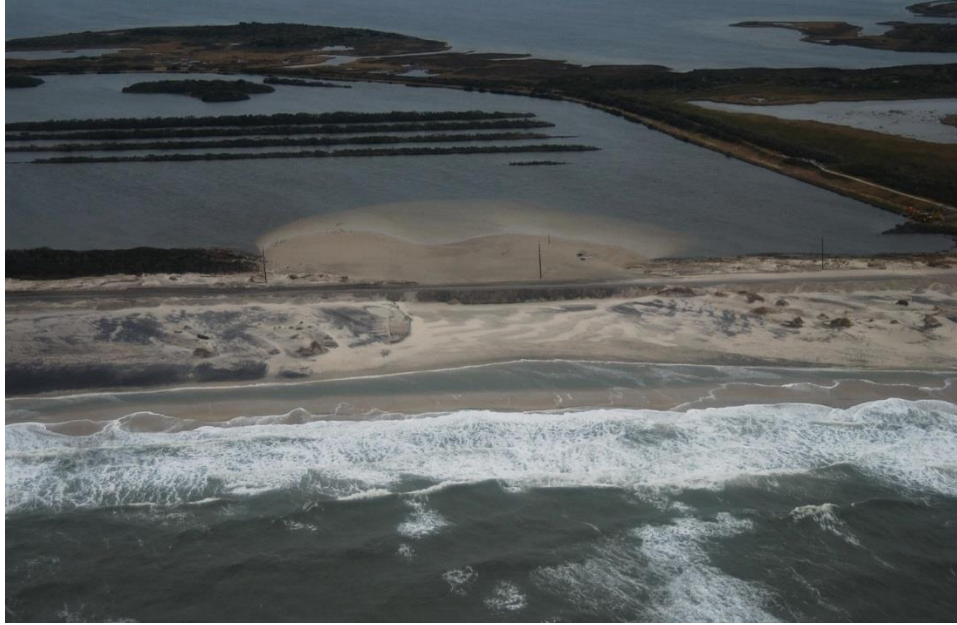
Figure 7. Overwash breached the dunes protecting North Carolina Highway 12 (NC 12) at Pea Island NWR in North Carolina, crossing the roadway and depositing an overwash fan in one of the refuge's impoundments. In this USGS (2015) image from November 6, 2012, the NC Department of Transportation has already removed the overwash from the roadway and piled the sediment on the beach as an artificial dune.

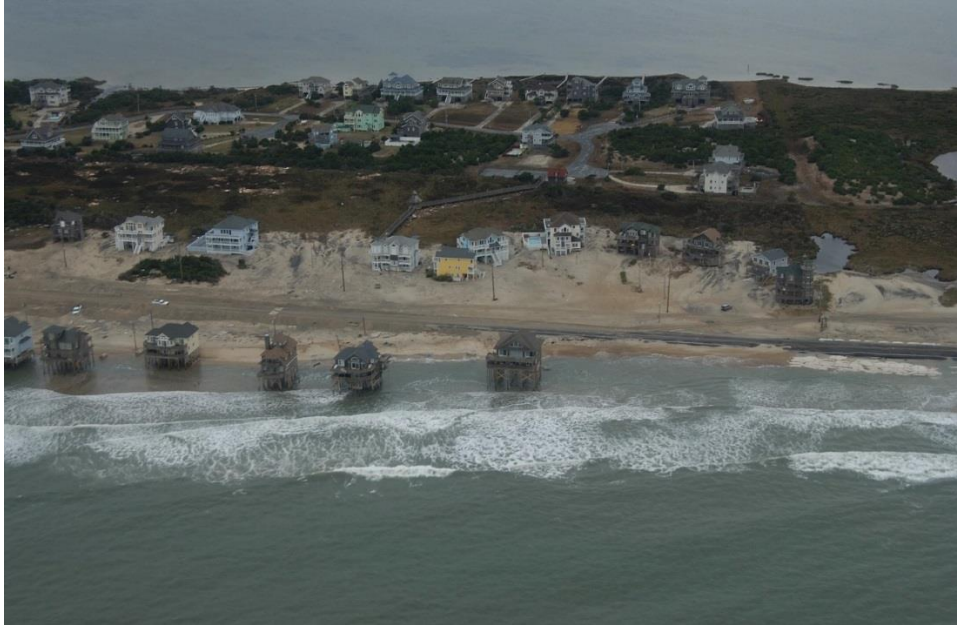
Figure 8. Hurricane Sandy deposited overwash in Rodanthe, NC, creating overwash fans in a developed area along NC 12. NC 12 is buried by overwash on the left side of the photo and undermined by erosional scour at the right side of the photo, where sandbags had been placed to protect the roadway. The sandy beach habitat has been modified by the storm to retreat landward and to remove any dunes. Image from USGS (2015) dated November 4, 2012.
