SEA LEVEL RISE RESILIENCY IN DELAWARE

Tidal Marsh Restoration At Prime Hook National Wildlife Refuge In Delaware

Tidal Marsh Restoration Design At Prime Hook National Wildlife Refuge In Delaware

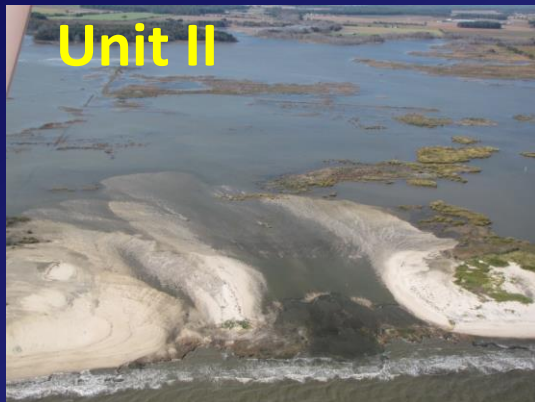
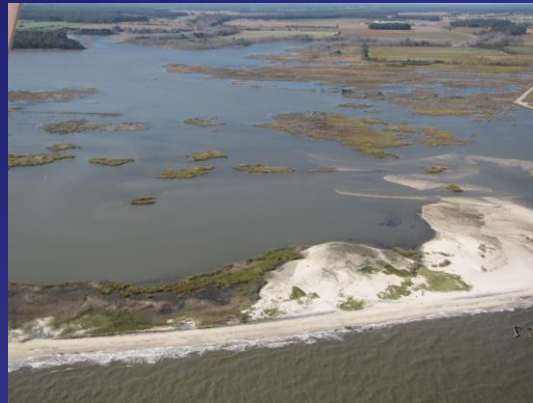
Breach formed in 2006 has since closed. Unit I serves as a Reference marsh for our restoration plans and monitoring

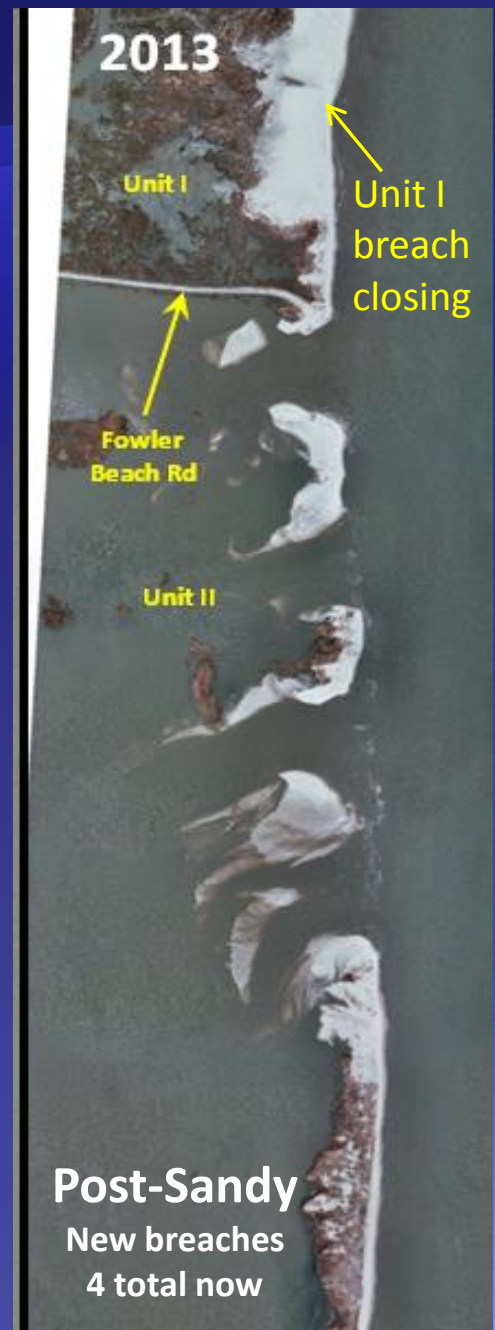
Because the back-barrier marsh had been converted to a freshwater impoundment 20+ years ago, Unit II could not tolerate rapid salt water introduction, and it could not handle the otherwise natural process of overwash and breaching
