NOAA RC Northeast Tidal Marsh Restoration Projects

Tidal Reconnection

Gooseneck Cove, Newport, RI

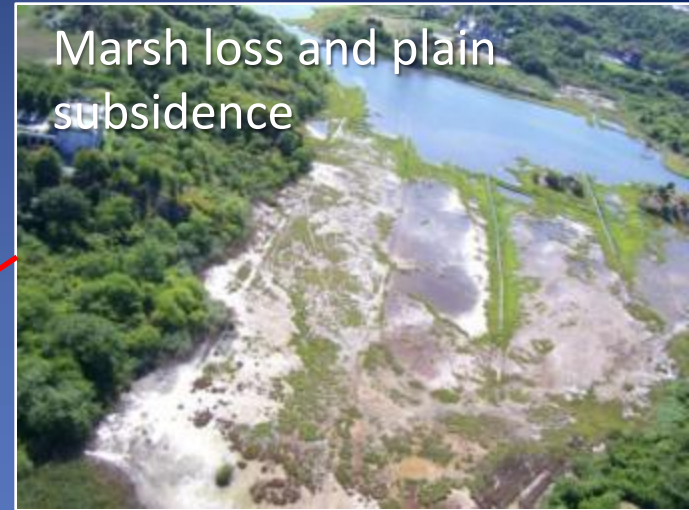
Decades of tidal restriction

Marsh loss and plain
subsidence

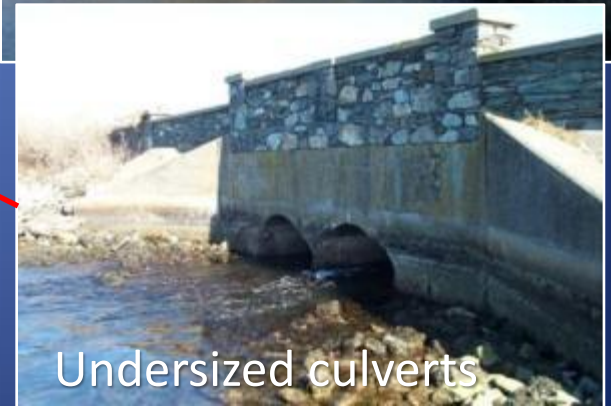
Undersized culverts

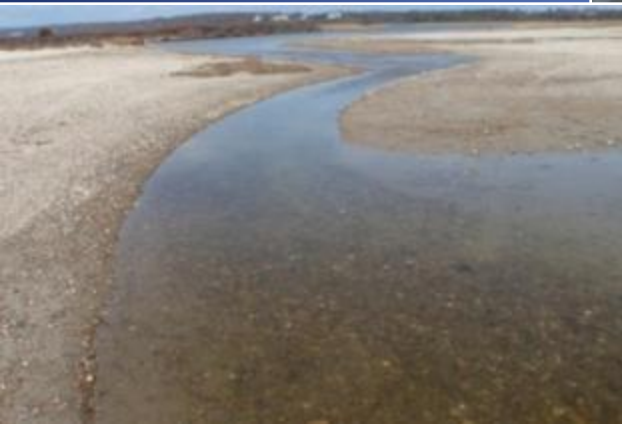
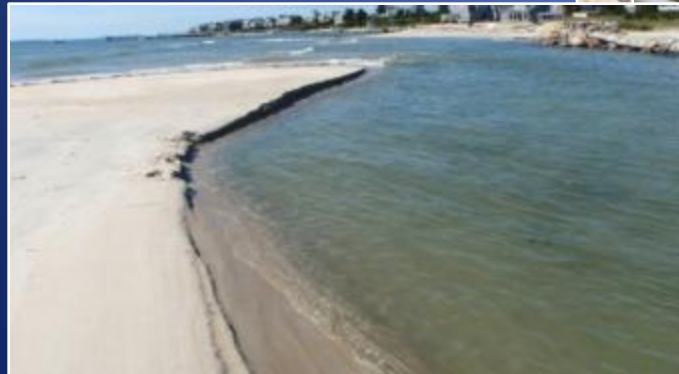
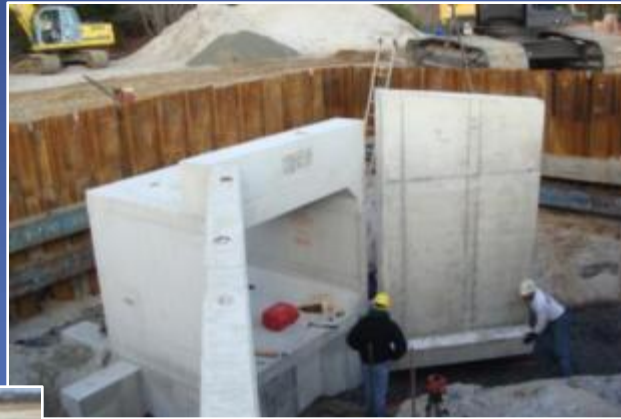
Beachfront
channel and
channel migration

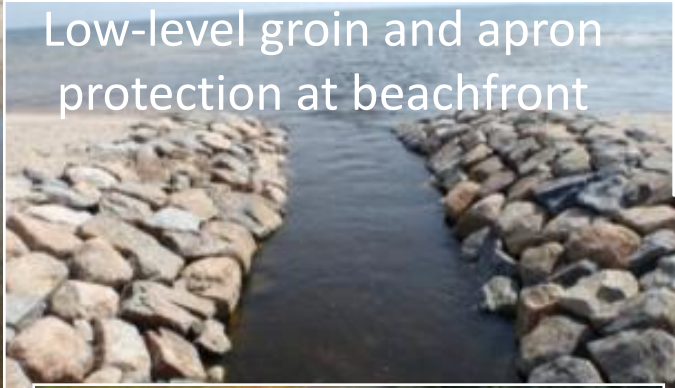
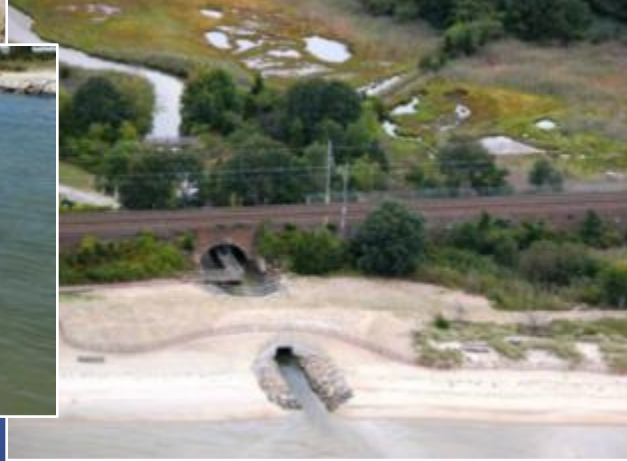
Low-level groin and apron
protection at beachfront

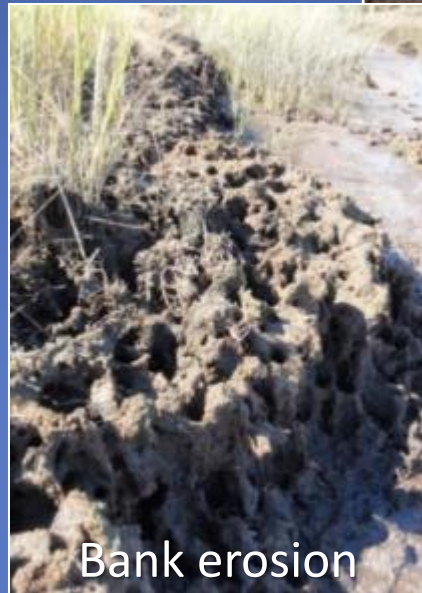
Bank erosion

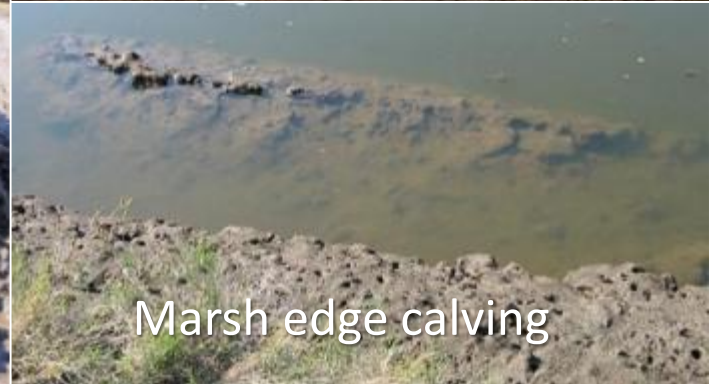
Marsh edge calving

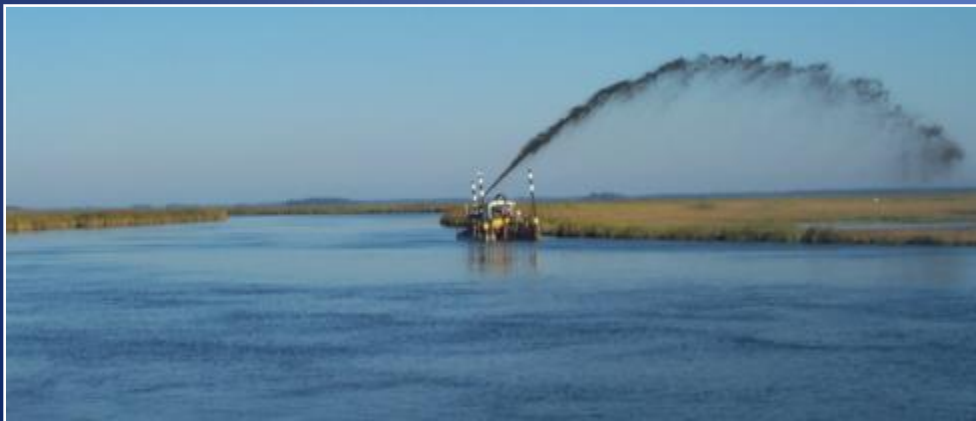
Slocum et al. 2005: intermediate (5-12 cm) soil placement depth resulted in greatest plant vigor over 7-yr period due with >elevation and bulk density; results: >plant cover, <hydrogen sulfides (mineral soil Fe/Mn precipitating hydrogen sulfide), plus shorter-term (≤ 3 yrs) nutrient and mineral enrichment benefit

Option of thin-layer slurry placement using pipes carrying slurry into marsh interior, as opposed to slurry spraying with limited spray distance

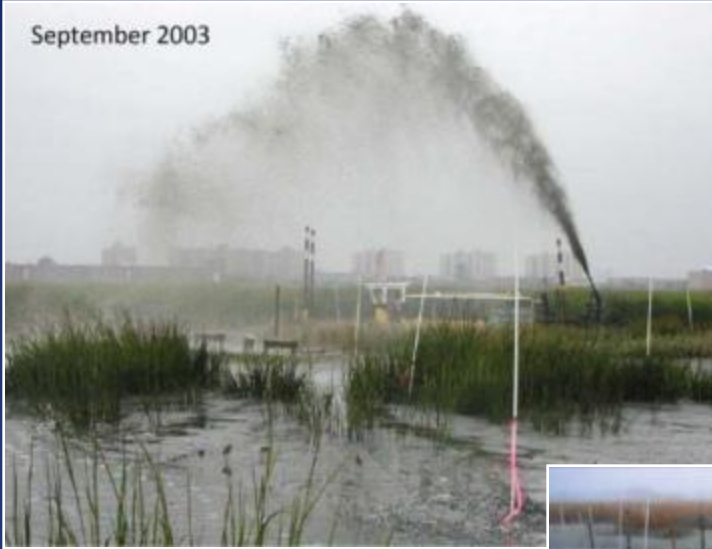
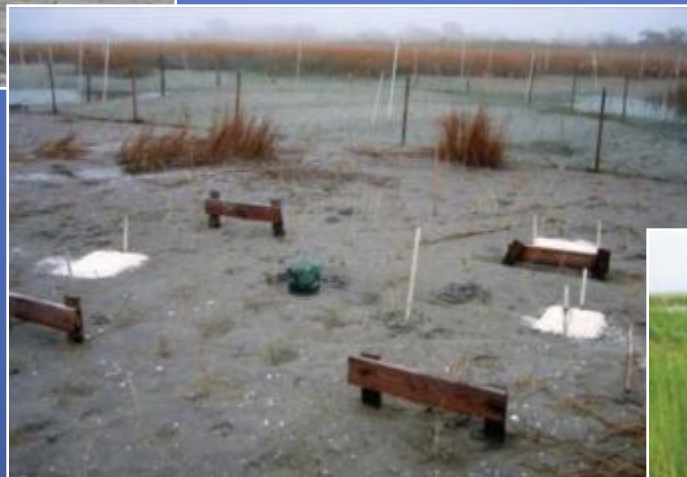
NPS 2-acre marsh restoration using spraying technique after Ford et al. (1999)

Up to 1.6 ft (0.48 m) gain in marsh plain elevation

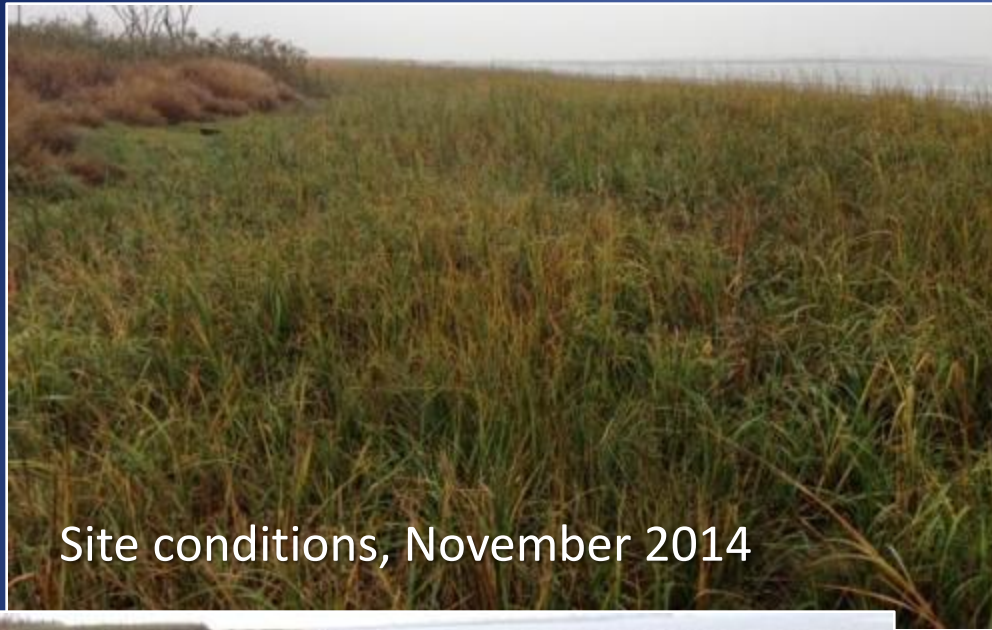
Jamaica Bay, Elders Point East: Fill placement, 2006

2-4 ft depth of compacted soils

High density of plantings (1.5-ft oc)

Coir logs installed for soil containment; coir log did not contribute functional purpose to soil stability; significant NW fetch contributes to soil erosion

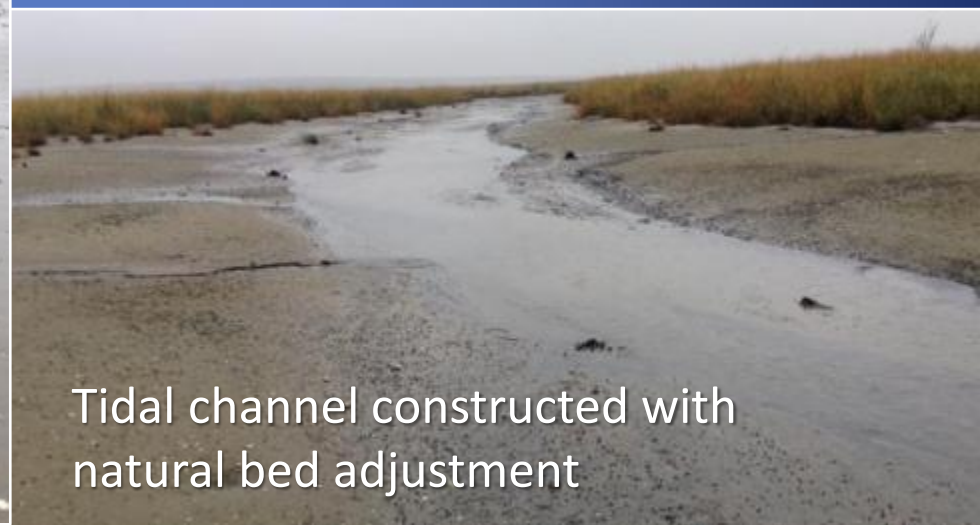
Tidal channel constructed with natural bed adjustment

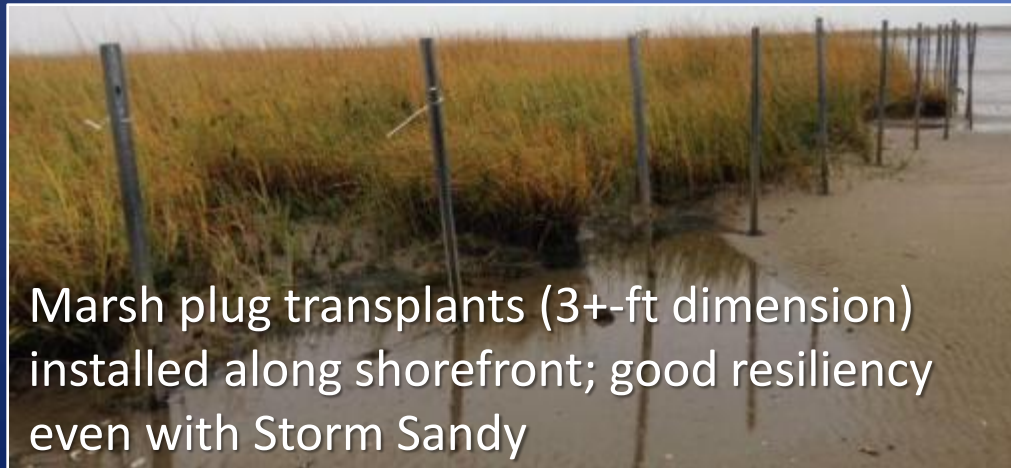
Marsh plug transplants (3+-ft dimension) installed along shoreline; good resiliency even with Storm Sandy

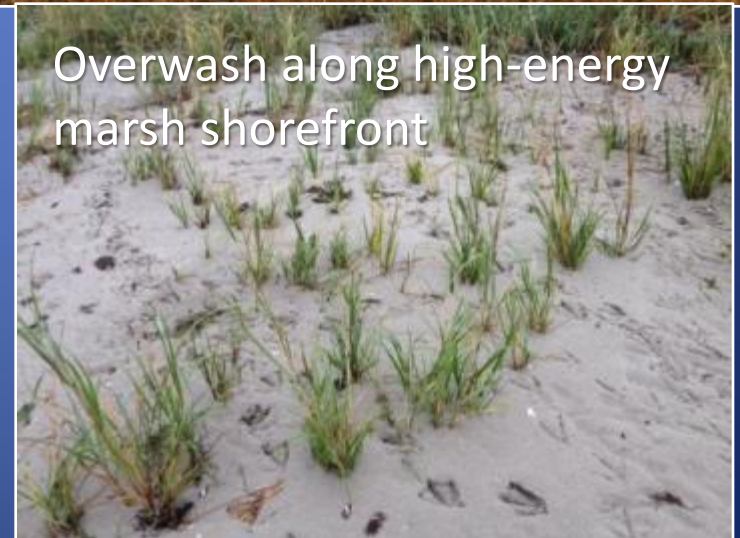
Overwash along high-energy marsh shoreline
