TIDAL CROSSING ASSESSMENT IN MAINE

**NROC/GOMC/NALCC Tidal Crossings
Assessments Workshop**

9/10/2015

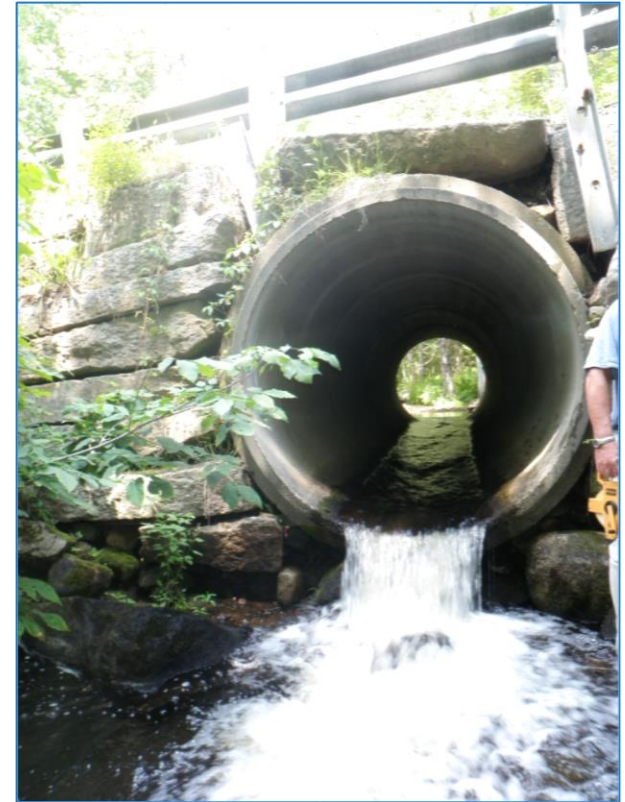
Statewide survey of road-stream crossings (2007 - present)

- Protocols: *Maine Road-Stream Crossing Survey Manual* (Abbott 2008, Rev. 2012)
- Identify barriers to improve stream connectivity and AOP
- Added tidal attribute in 2012
- Currently, data on 16,267 sites.
Queries:
 - 162 sites currently listed tidal
 - 239 sites within >75 m of tidal marsh
 - 106 sites within >75 m of NWI estuarine or marine

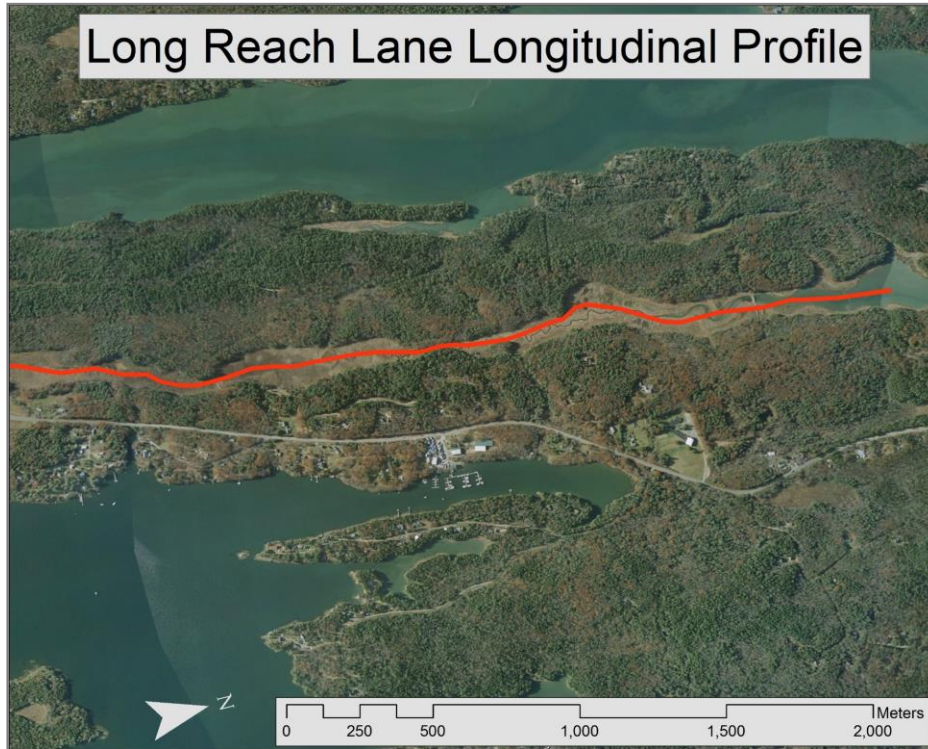
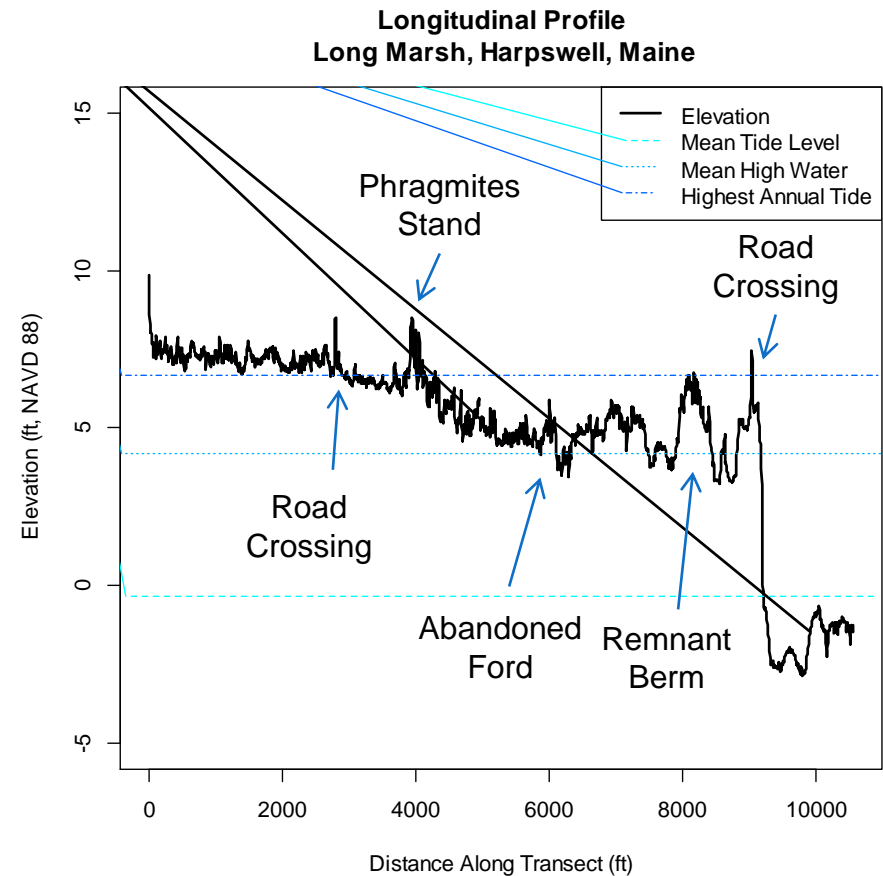
Longitudinal Elevation Profiles from LIDAR (CBEP, 2012)

SOURCE: *Geomorphology and the effects of sea level rise on tidal marshes in Casco Bay*. C. Bohlen et al., CBEP 2012
